## Test Report

No. : CE/2019/62215

Sample Submitted By : MURATA MANUFACTURING CO., LTD.  
Sample Description : Sn PLATING\_190621  
CLIENT REF No : 1190528018  
Sample Receiving Date : 2019/06/14  
Testing Period : 2019/06/14 to 2019/06/21

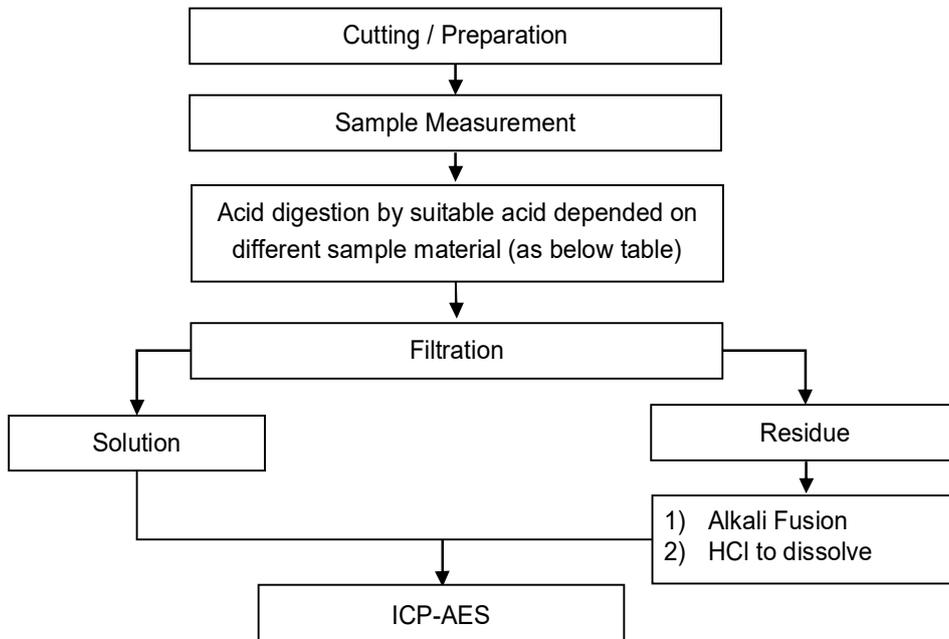
### Flow Chart of digestion for the elements analysis performed by ICP-AES

These samples were dissolved totally by pre-conditioning method according to below flow chart.

Steel, copper, aluminum, solder	Aqua regia, HNO <sub>3</sub> , HCl, HF, H <sub>2</sub> O <sub>2</sub>
Glass	HNO <sub>3</sub> /HF
Gold, platinum, palladium, ceramic	Aqua regia
Silver	HNO <sub>3</sub>
Plastic	H <sub>2</sub> SO <sub>4</sub> , H <sub>2</sub> O <sub>2</sub> , HNO <sub>3</sub> , HCl
Others	Added appropriate reagent to total digestion
